NEOBIOTECH

USER'S
CLINICAL
CASES

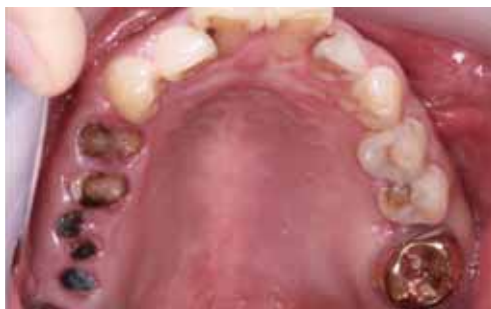
Fig.2 On the occlusal view, rampant caries were observed.

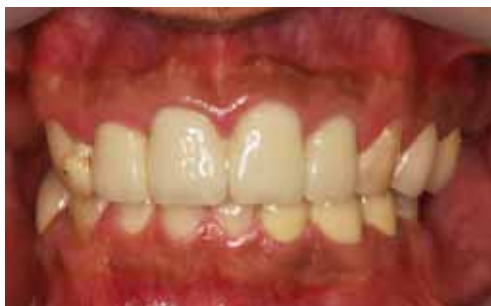
Fig.6 Clinical photograph 4 years later. Dental caries on #13 and 23 were observed due to the patient's poor oral hygiene. Maxillary anterior teeth also had secondary caries underneath the crowns.

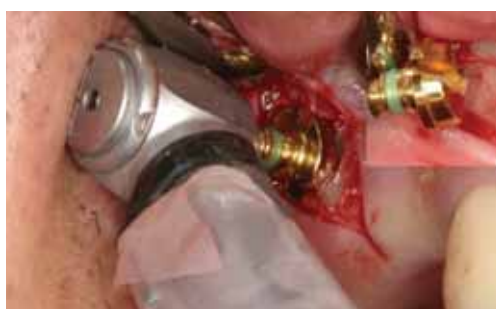
Fig.7 The LS-reamer was used to make a lateral hole. The reamer should be tilted side to side for depth control while the operator should watch carefully the osteotomy site. When it gets closer to the sinus membrane, the color becomes bluish or dark.

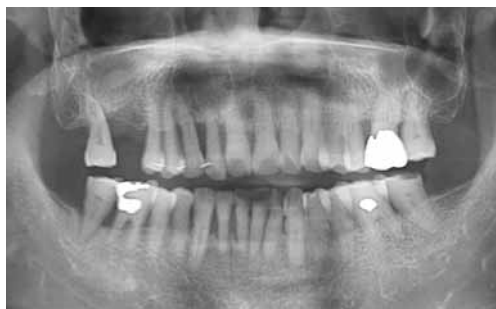
Fig.1 Initial panoramic view: severe pneumatization of right maxillary sinus and periodontally compromised teeth #17, 12, 46 and 47 were observed.

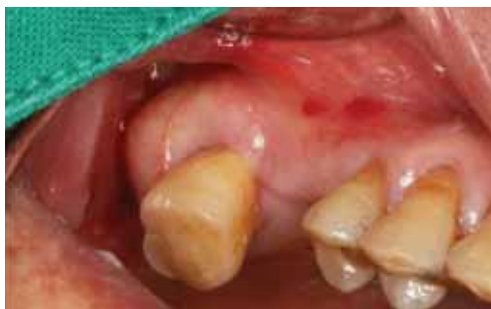
Fig.2 A picture before surgery (after anesthesia). It shows abundant keratinized gingiva. Deep periodontal pockets existed in the buccal (7mm) and lingual (8mm) sides.

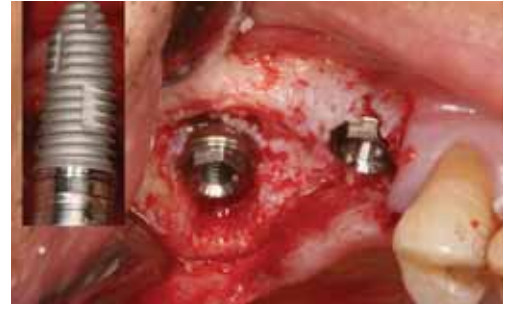
Fig.8 Initial stability of #16 and 17 implant was about 40 Ncm. The bone defect around implant #17 is observed.

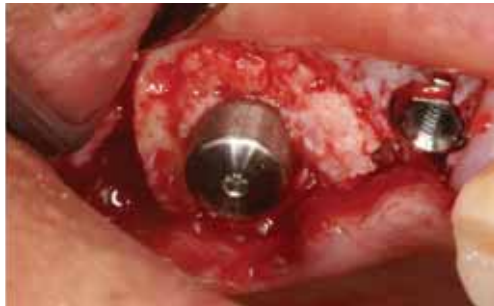
Fig.9 Autogenous bone collected from a maxillary tuberosity was filled between extraction socket and implant after healing abutment connection.

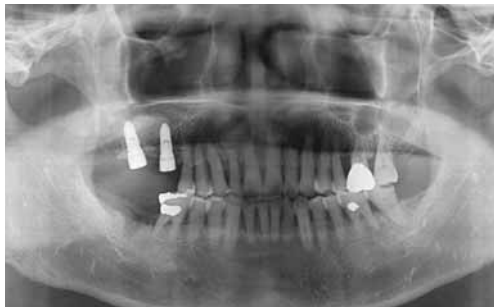
Fig.11 A panoramic x-ray after surgery. Well-grafted, dome-shape bone graft material around #16 and #17 implant can be observed.

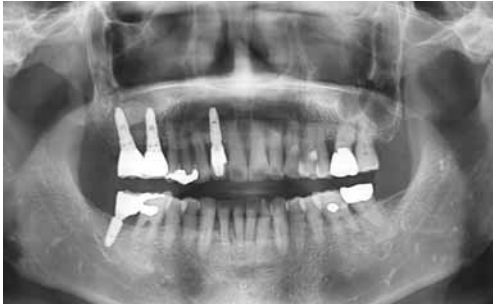
Fig.13 While waiting for the healing time, implants in the #12 and 47 area were placed and delivered at the same time. A panoramic x-ray at the delivery of a definitive prosthesis. (2 unit PFM SCRPs)

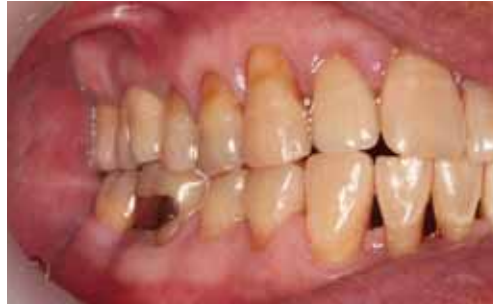
Fig.14 Buccal view of left side in centric occlusion.

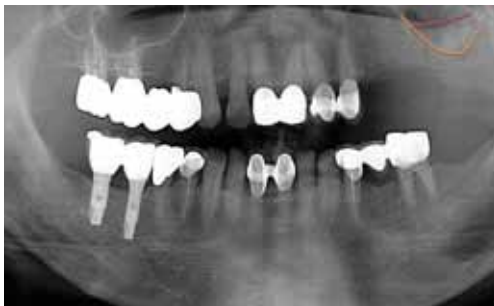
Fig.5 The sinus floor on site #26 was augmented by the crestal approach using SCA kit.

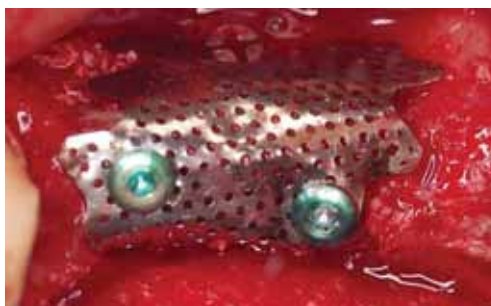
Fig.8 A combination of autogenous bone and allograft was applied to the defect. E2 type of CTI-mem was placed and 3 point fixation was made using two cover screws and one fixing screw over the graft.

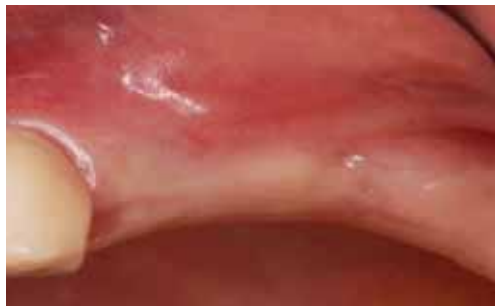
Fig.13 No CTi-mem exposure was observed at 16 weeks after the surgery. It would be due to the ideal fixation of the CTi-mem.

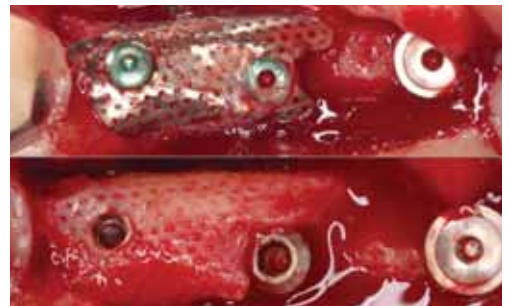
Fig.14 4 months later, CTi-mem was uncovered and it was verified that new bone formation has been made on the buccal and the lingual side.

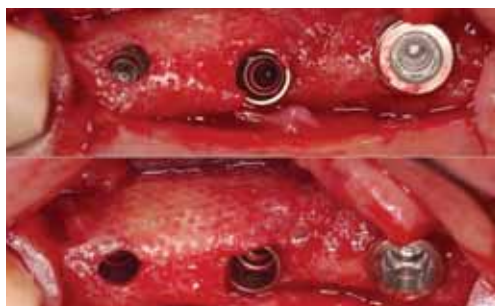
Fig.15 Complete bone regeneration was observed following the spacer removal.

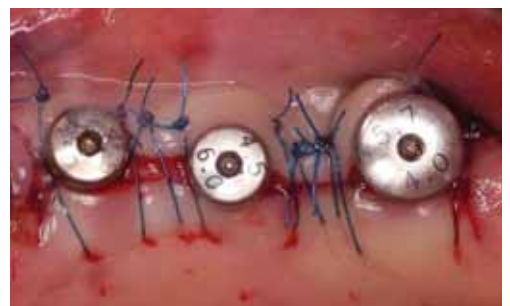
Fig.16 Healing abutments are in place. The flap was apically positioned to achieve keratinized gingiva.

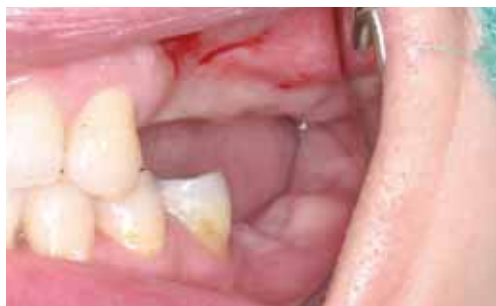
Fig.1 Lateral view of the maxillary left edentulous ridge before surgery. Vertical space is adequate but lateral deficiency on the buccal side of the edentulous ridge is shown.

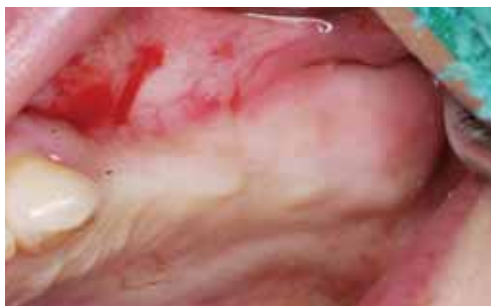
Fig.2 On the occlusal view, the lateral deficiency can be better visualized.

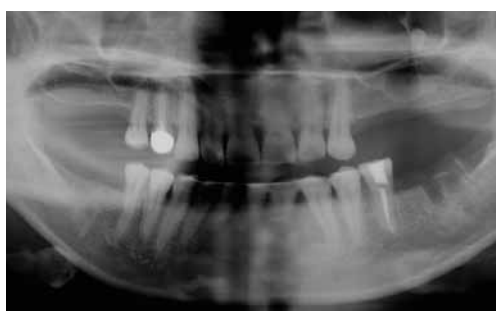
Fig.3 Panoramic x-ray : Multiple septa are seen in both right and left sinuses. Due to the amount of bone graft required, crestal approach for the anterior part and lateral approach for the posterior part of the sinus are preferred. In the posterior region, the number of implants required should match the number of missing teeth.

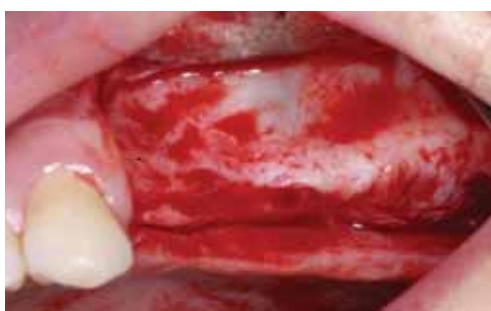
Fig.4 After the flap is reflected, it turned out the buccal bony deficiency did not require advanced buccal bone augmentation. The dark shadow shown on the buccal side implies the lateral wall of the sinus is very thin.

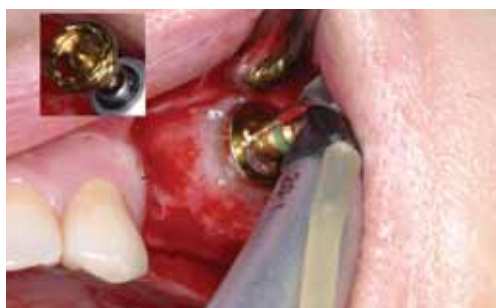
Fig.5 The C-reamer was used for lateral sinus graft. Drilling with 2000 rpm or faster is recommended for the C-reamer.

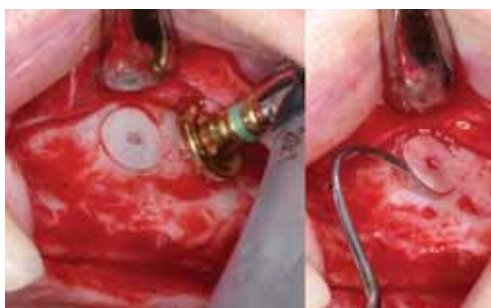
Fig.6 A dark shadow is seen under the outline of the C-reamer. During window preparation with the C-reamer, the reamer should not touch the sinus membrane directly. To avoid membrane perforation, osteotomy should not be performed in full depth and the bone core should be removed by green stick fracture. When the shadow becomes darker, it implies that the reamer is getting closer to the membrane (Left). The cut-out bone core is detached from the membrane by an explorer after fracture by tapping. (Right)

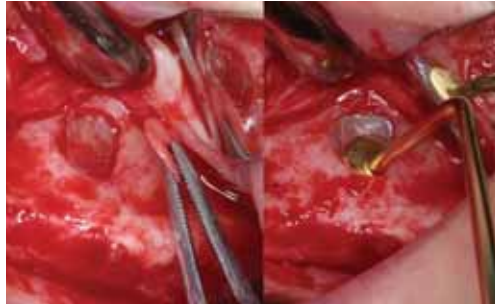
Fig.7 Note the bone core is very thin and the sinus membrane is now visible through the window. This membrane was detached by a mushroom elevator all around the window hole but it can tear the membrane if the sinus wall has an irregular or sharp surface, or septum. In that case, the other #01micro-elevator should be used.

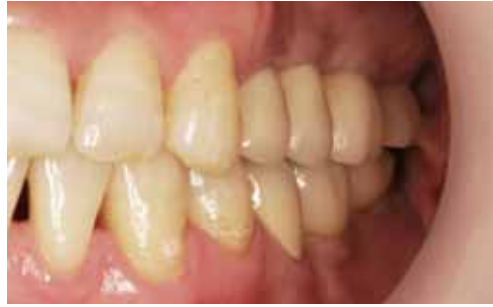
Fig.14 Buccal view of the final prostheses.

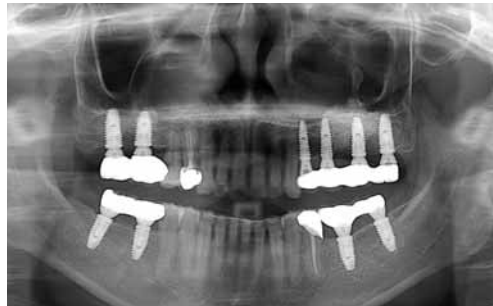
Fig.16 Panoramic x-ray. (5 year follow-up)

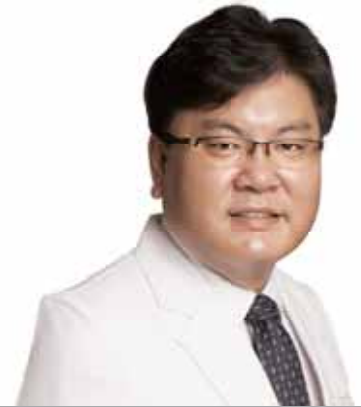
Dr. Nam Yoon Kim
DDS, MSD, Ph.D

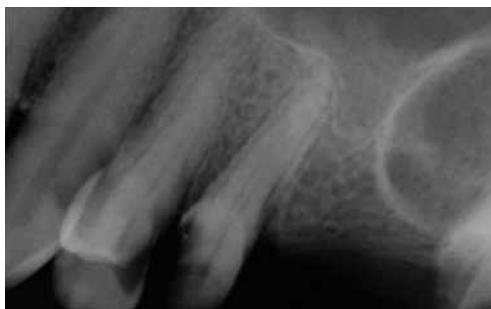
Fig.2 Periapical x-ray after removal of the previous prosthesis. #27 was extracted due to severe caries. Near the root apex of #25, pneumatization of the sinus inferior wall was observed.

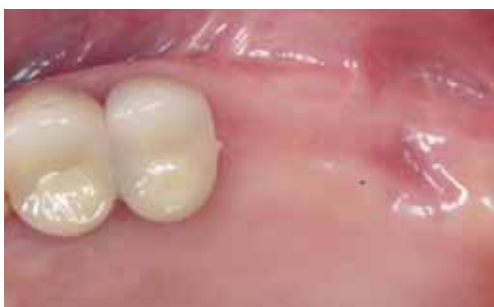
Fig.3 #26 & #27 are missing. #27 was extracted 6 weeks previously.

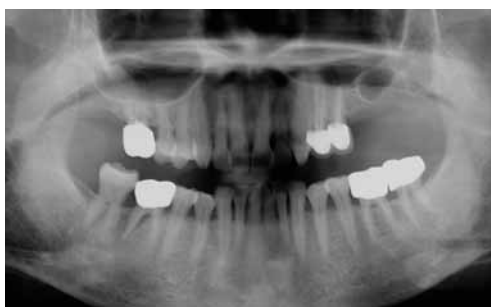
Fig.4 6 weeks after the extraction of #27. There seemed to be some remaining bone at #27 site. #26 site was planned to obtain a Class II/III fixation by passing through the mesial slope of the sinus and septum with the S-reamer.

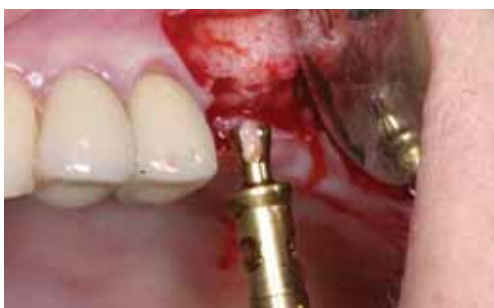
Fig.5 After the initial osteotomy up to the depth just short of the final depth with initial straight drill, the last part of the osteotomy to penetrate the sinus septum was performed with the S-reamer of 3.2mm diameter with a 5mm stopper. Drilling at 1000-2000 rpm with copious irrigation is recommended for this procedure.

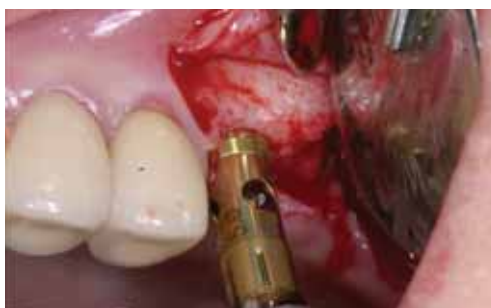
Fig.6 The S-reamer in the SCA kit was used to drill into the sinus cavity to achieve Class III CM fixation. Based on the radiographic analysis, residual bone height was expected to be 4-5mm.

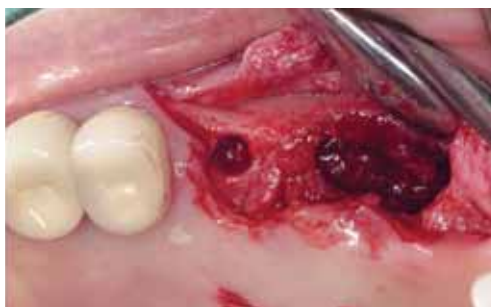
Fig.8 The cortical wall of the sinus septum of #26 area was eventually opened at 7mm drilling. In the #27 and #28 area a large defect was observed. The membrane fused to the soft tissue of the gingiva was cut, separated and detached from the sinus bony wall.

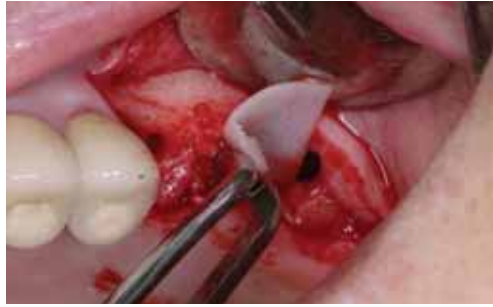
Fig.9 A collagen membrane (Lyoplant) was placed to cover the soft tissue layer, to separate the membrane from grafted bone and to prevent the downgrowth of soft tissue.

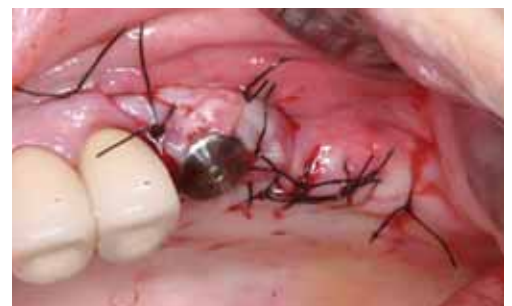
Fig.16 The #16 implant was non-submerged and a healing abutment was connected after implant placement. Mattress suture is usually recommended for adequate eversion of the flap. In this case, simple interrupted and modified mattress sutures were done due to the thick gingiva.

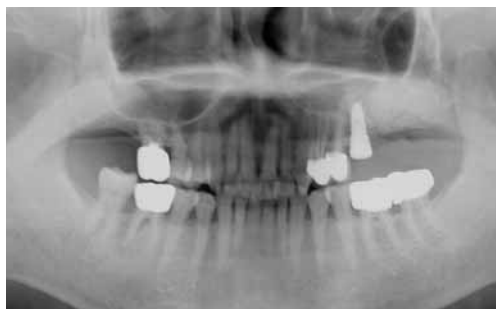
Fig.17 Panoramic x-ray after surgery. The distinct outline of the grafted bone is visible. The #26 implant was loaded in 3 months by a provisional crown.

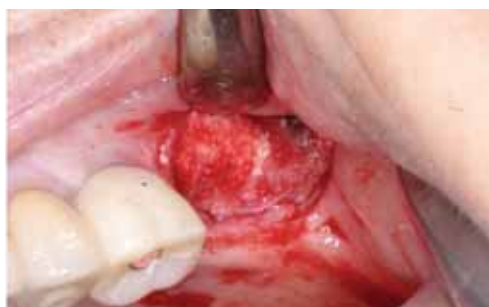
Fig.20 The removal of the CTi-mem is easier than other Titanium meshes. Underneath the Ti mesh, a solid bone mass was observed.

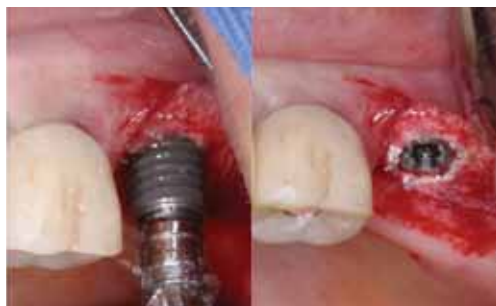
Fig.21 A 5.0x10mm CMI IS-II active fixture was placed 1mm subcrestally in the grafted bone only. The bone density and ITV were D333 and 20 Ncm.

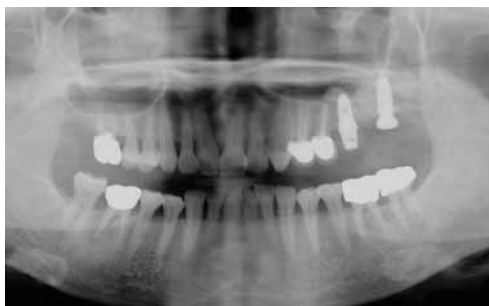
Fig.22 Panoramic x-ray after the placement of implant #27. The delivery of the final prosthesis is scheduled four months after implant placement.

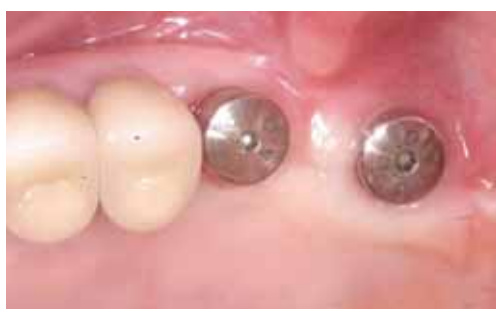
Fig.23 Occlusal view (4 months post-op) : Adequate amount of attached gingiva is present around #26, but not on the buccal aspect of #27.

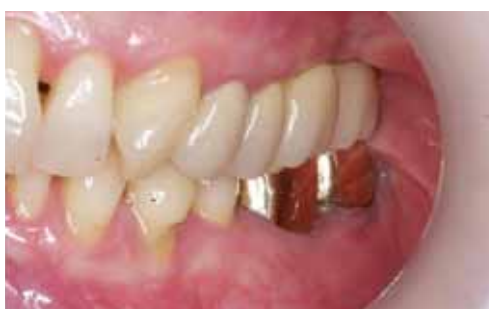
Fig.24 Upon light biting, a piece of shimstock should loosely pass through the two opposing occlusal surfaces. Heavy biting, however, should hold the shimstock between upper and lower teeth.

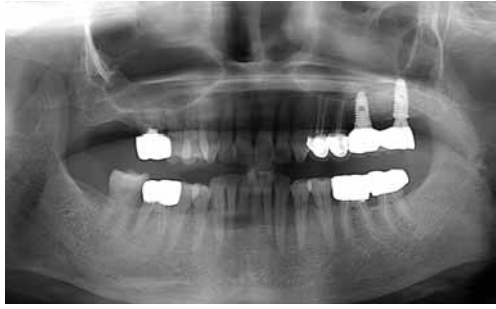
Fig.25 Panoramic x-ray after the delivery of final prosthesis.

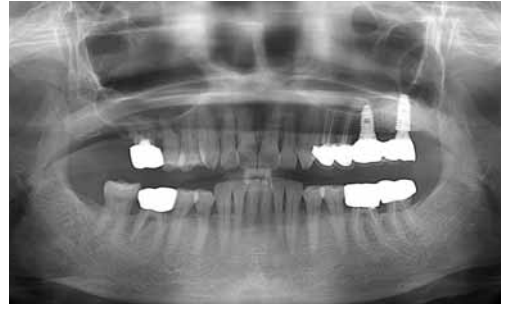
Fig.26 Panoramic x-ray (5 year follow-up) : No marginal bone loss is observed around implants, specially in the #27 grafted area.

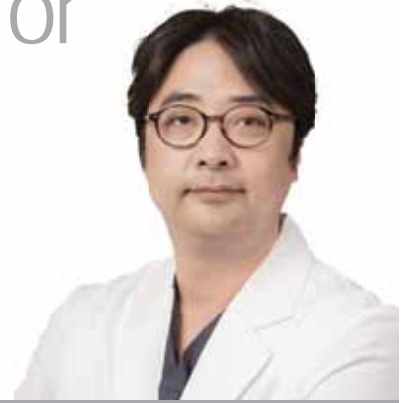
Dr. Jongyub Kim
DDS, MS, Ph.D

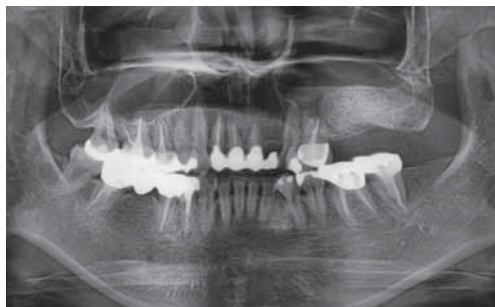
Fig.15 Panoramic view right after sinus graft.

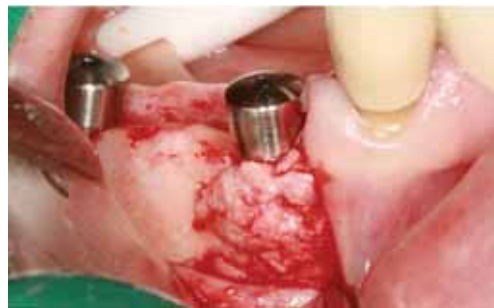
Fig.6 Healing abutments were connected to the fixtures. Autogenous bone chips harvested from the adjacent ridge area was grafted in the defect.

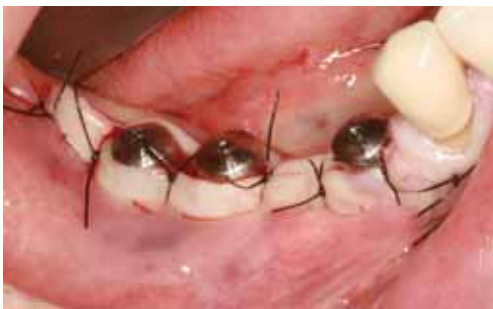
Fig.7 Non-submerged approach was done and the wound margins were closed with sutures.

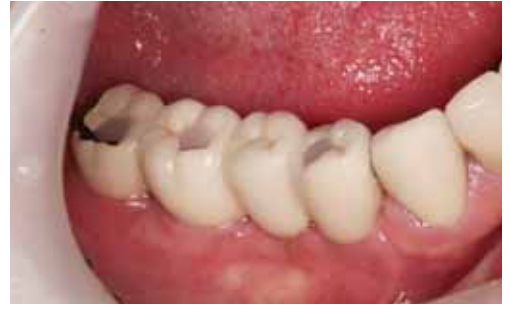
Fig.10 A definitive 4 unit SCRCP prosthesis was delivered 8 weeks after implants placement.

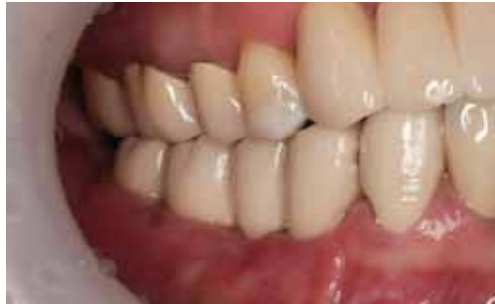
Fig.11 Lateral view of right mandible after treatment.

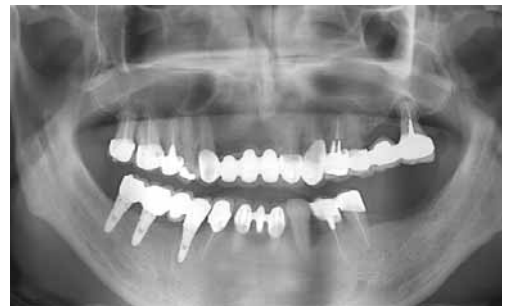
Fig.14 Panoramic view after delivery of the prosthesis.

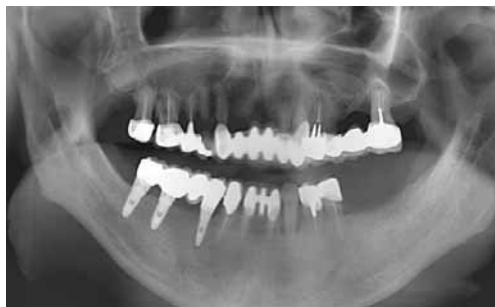
Fig.15 A month of follow-up after delivery of final prosthesis.

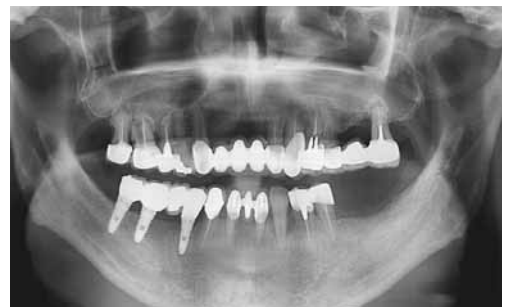
Fig.16 8 months of follow-up panoramic view.

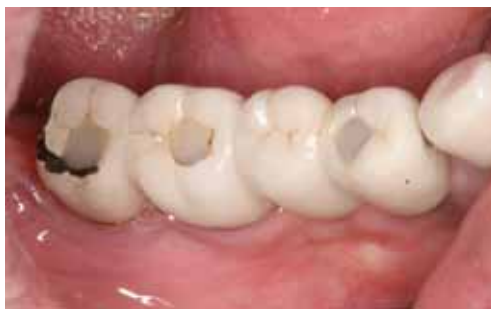
Fig.18 4 year follow-up on the final prosthesis.

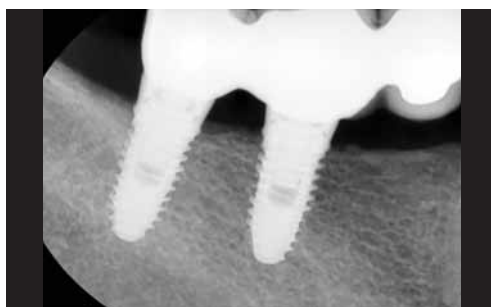
Fig.20 4 year follow-up on the final prosthesis.

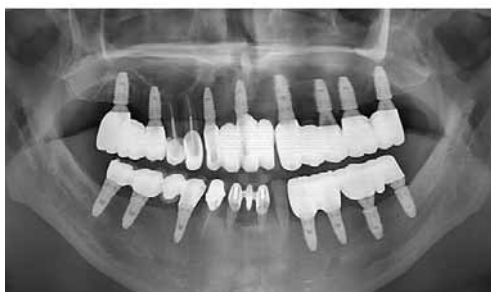
Fig.22 8 years postoperative panoramic radiograph showing well maintained implants without any noticeable bone loss.

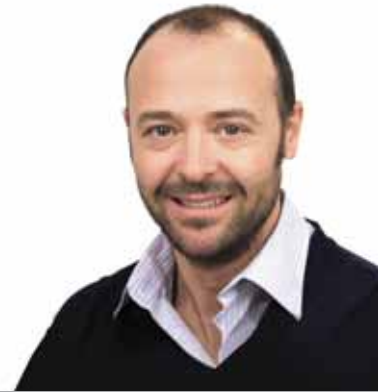
Dr. Michele Perelli
DDS

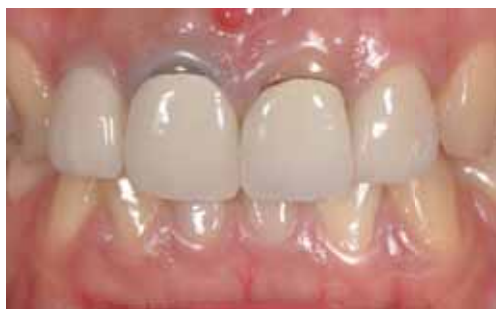
Fig.1 A sinus tract was noted on the buccal surface between #11, #12.

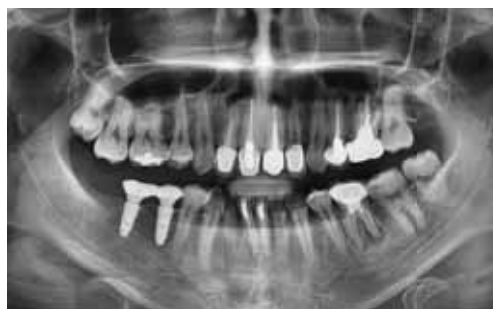
Fig.2 Pre-op Panoramic Radiograph.

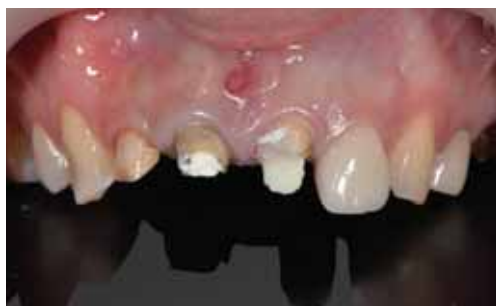
Fig.5 Crowns were removed and re-endo Tx was done for #11, 12, 21. However, the lesion was not resolved. So patient was recommended to remove #21 and place an implant immediately after extraction.

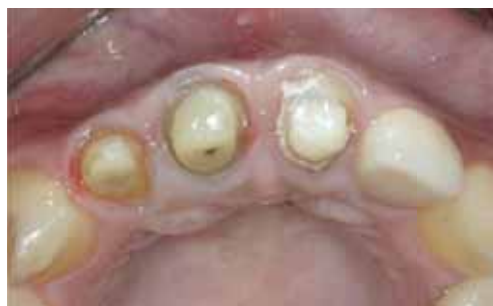
Fig.6 Post-Retreat 2 weeks.

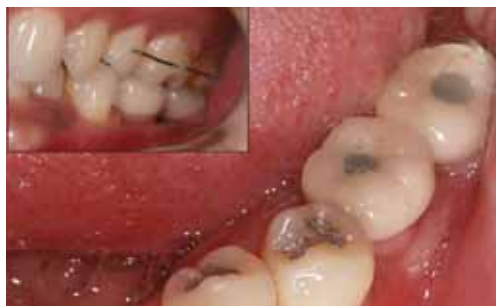
Fig.21 Prosthetic delivery.

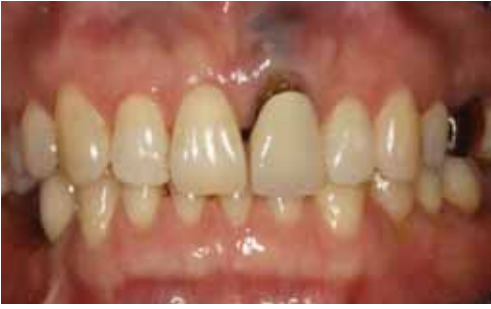
Fig.1 Facial view, gingival recession and supereruption on the tooth #21. Thin gingival biotype was observed.

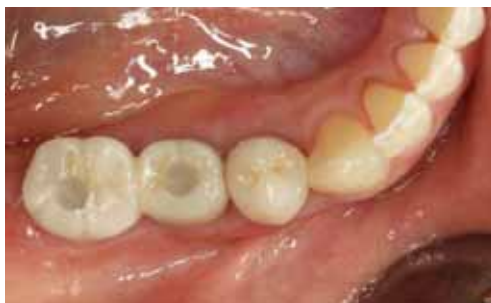
Fig.22 Final prosthesis of the tooth #45,46.

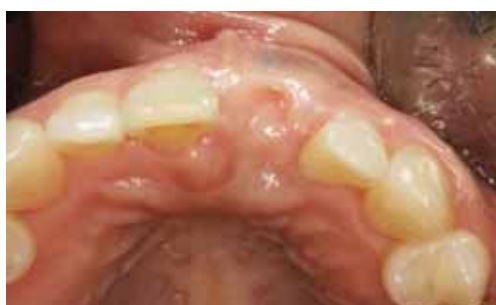
Fig.23 Healing after 4 month of #21 implant placement.

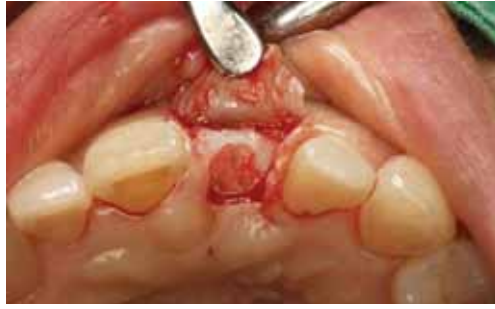
Fig.25 Facial bone regeneration was observed.

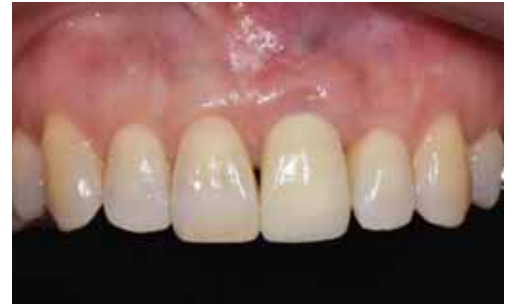
| Fig.44 Final prosthesis, facial gingival recession was restored.

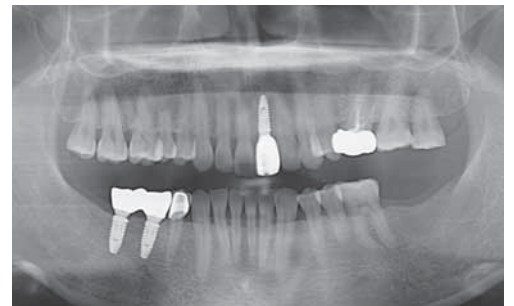
| Fig.46 Final prosthesis, panoramic X-ray.

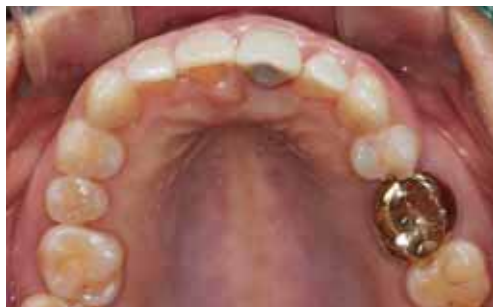
| Fig.47 Final prosthesis, occlusal photo.

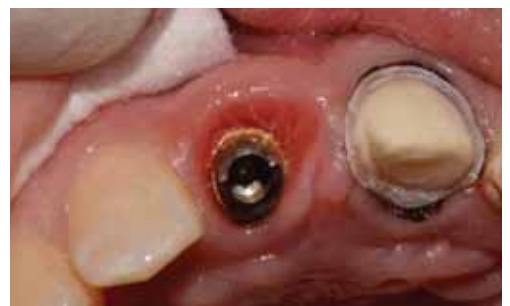
Fig.32 FINAL PROSTHESIS. CEMENTABLE UCLA ABUTMENT WAS USED.

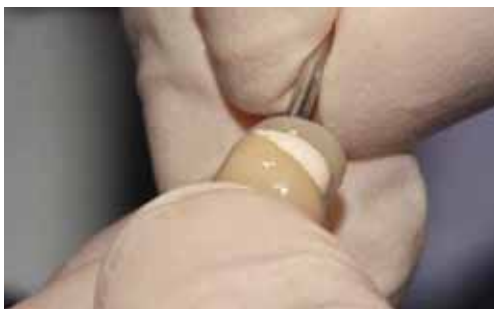
Fig.33 FINAL PROSTHESIS.EXCESS CEMENT REMOVED FROM A DUPLICATED DIE.

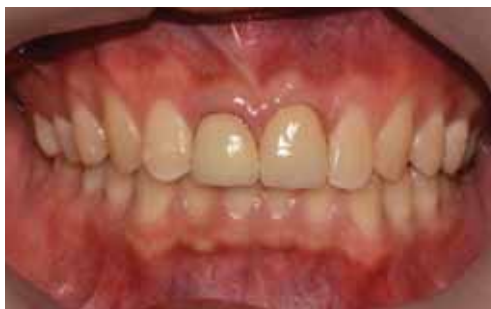
Fig.34 FINAL PROSTHESIS.FRONTAL VIEW.

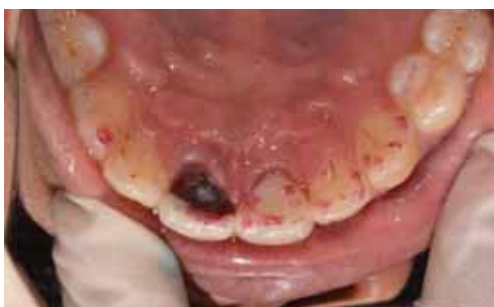
Fig.35 FINAL PROSTHESIS. EVEN OCCLUSAL CONTACT.

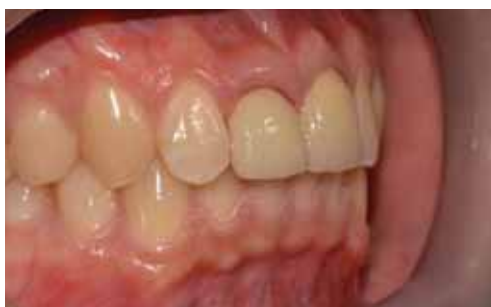
Fig.36 FINAL PROSTHESIS.

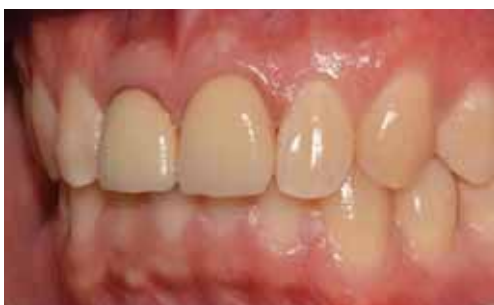
Fig.37 FINAL PROSTHESIS.

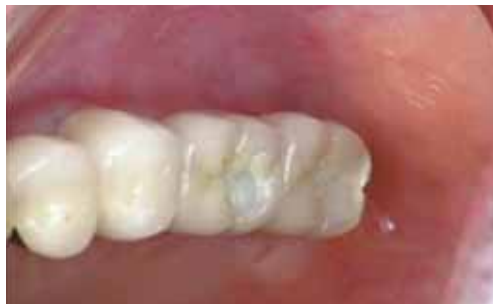
Fig.13 SCRP type prosthesis. Occlusal adjustment and polishing were done after the access hole was filled with composite resin.

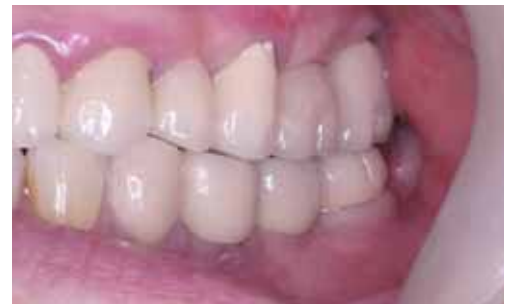
Fig.14 A buccal view of a definitive 2 unit PFM prosthesis (SCRP) in maximum intercuspation.

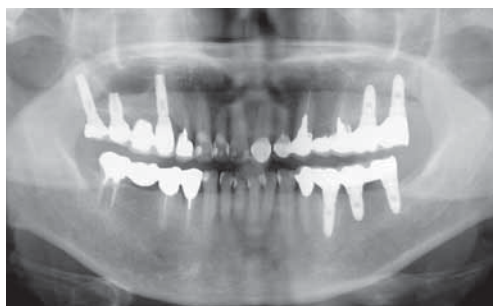
Fig.15 Panoramic view after the delivery of the definitive prosthesis. Graft material around the implants was well maintained.

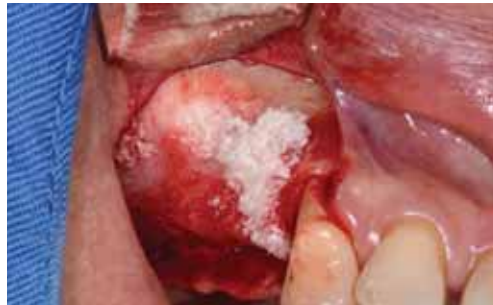
Fig.4 Additional bone graft was made to the defect on a premolar site.

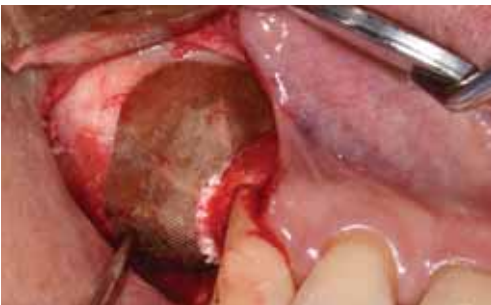
Fig.5 A titanium mesh was placed over the graft.

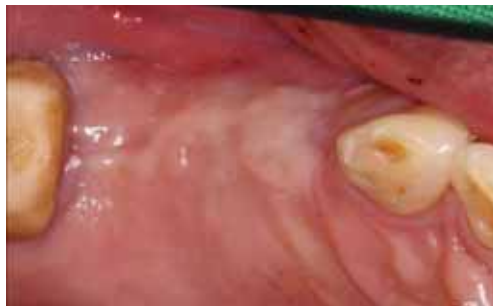
Fig.13 5 months postoperative clinical view. No membrane exposure was found.

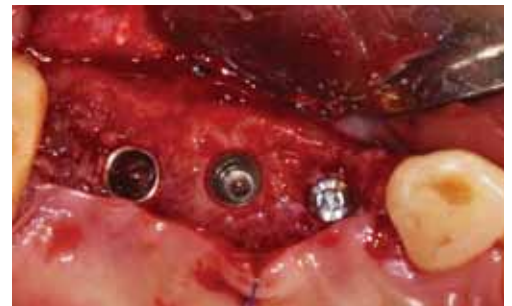
Fig.14 3 implants were successfully placed due to good bone formation made on the buccal side.

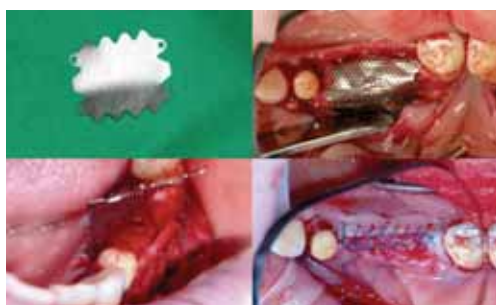
Fig.3 As shown on the lower left photo, the ridge has widened quite a bit after the ridge split and GBR. The Ti-Mesh was fixed with bone screws, and periodontal releasing incision was performed. Flap was sutured with primary closure. (10/13/2014)

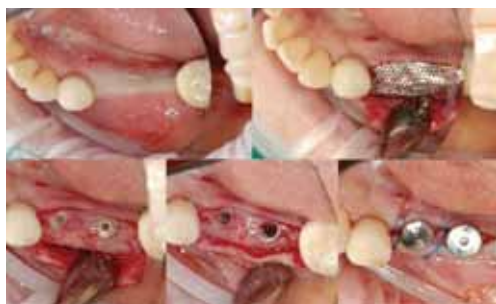
Fig.5 Second surgery. (02/25/2015) The epithelium has become thinner due to Ti-Mesh's good ability of space keeping. When the surface layer of the epithelium was opened, the Ti-Mesh remained well fixed. Complete bone regeneration was observed following the removal of the Ti-Mesh. New bone was created widely on the sides of the placed implants.

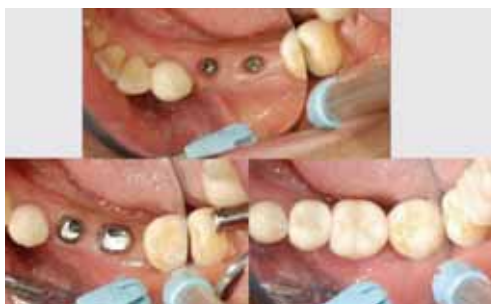
Fig.6 Good soft tissue healing was seen after second surgery. Impression of #35 & #36 was taken. (3/16/2015) The three photos were taken while connecting the CAD/CAM Abutment and delivering the temp cr. (04/15/2015)

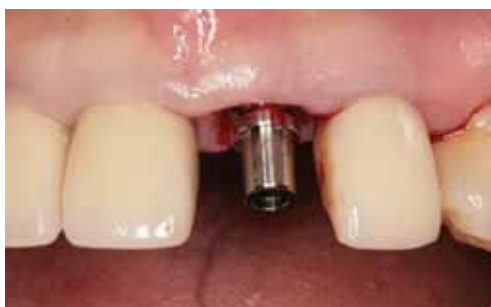
Fig.20 A SCR(Screw-Cement Retained Prosthesis) temporary abutment for IS type was connected.

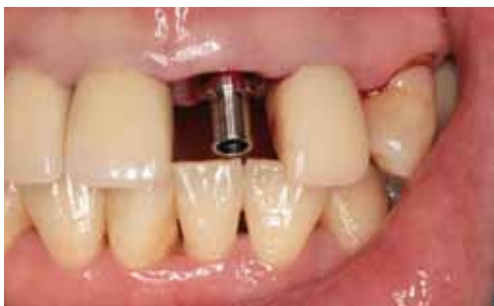
Fig.21 A SCR(Screw-Cement Retained Prosthesis) temporary abutment for IS type was connected.

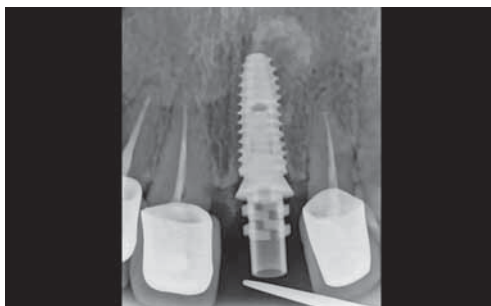
Fig.22 Postoperative radiograph of the implant in place with a provisional abutment.

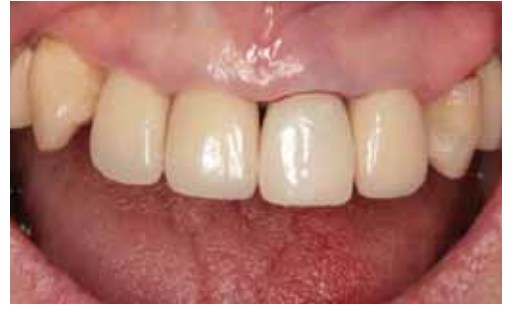
Fig.26 Frontal view of the patient's smile. Temporary restoration provided to the patient on the surgery day reduces the stress caused by the treatment and allows to return to the daily life immediately.

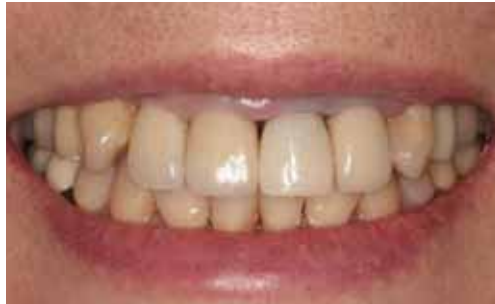
Fig.27 Provisional restoration was immediately delivered on the day of the surgery.

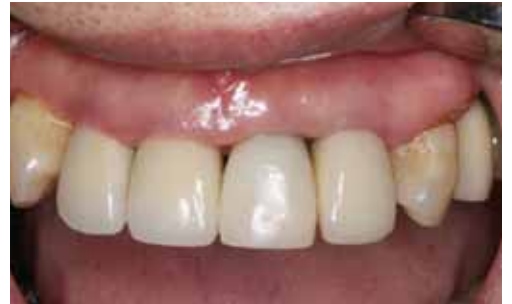
Fig.28 Final prosthesis. (Single SCRP crown)

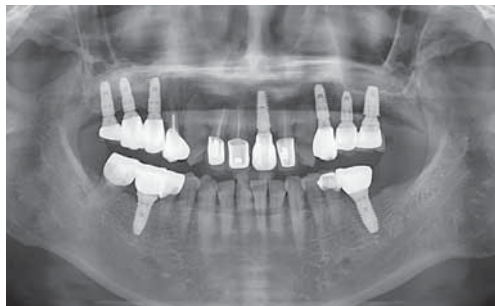
Fig.29 3-year follow-up.

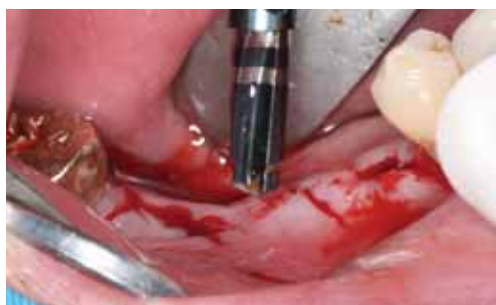
Fig.5 Enough drilling for the implant placement with the appropriate Stopper connected to the drill with irrigation. (Recommended speed : 1,200rpm)

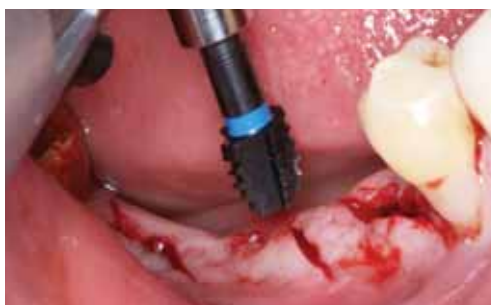
Fig.6 Tapping with irrigation.

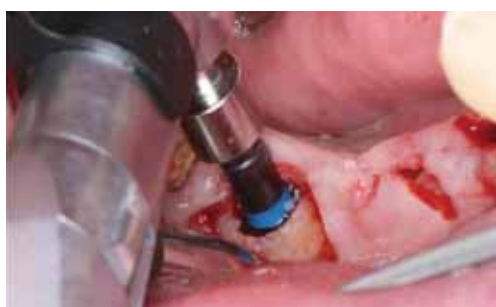
Fig.7 Recommended speed when using the Cortical tap : 50rpm.

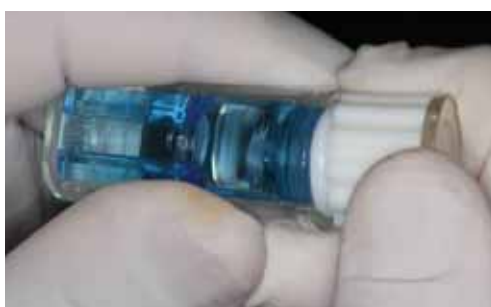
Fig.8 Open the sterilized package after checking the type, size and expiration date of implant specified on the label and packaging status.

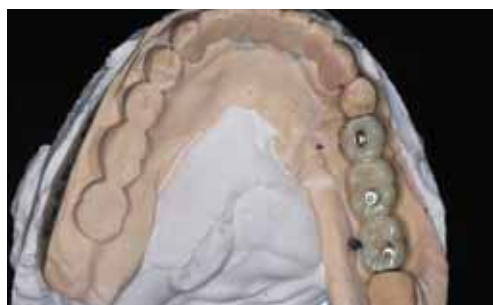
Fig.22 A definitive 3-unit zirconia SCRPFD were fabricated.

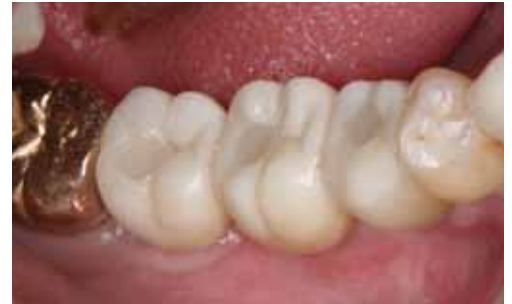
Fig.28 The prosthesis was repositioned and the screw holes were occluded by resin.

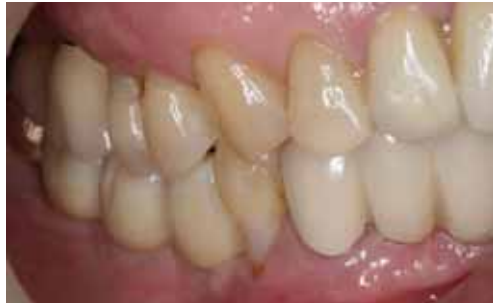
Fig.29 Lateral view of right mandibular after delivery of restorations.

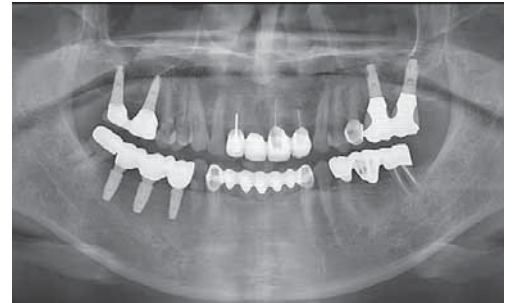
Fig.30 Panoramic view after delivery of the prosthesis.

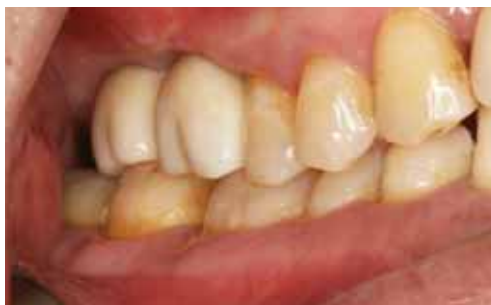
Fig.4 Lateral view : The final prosthesis in occlusion.

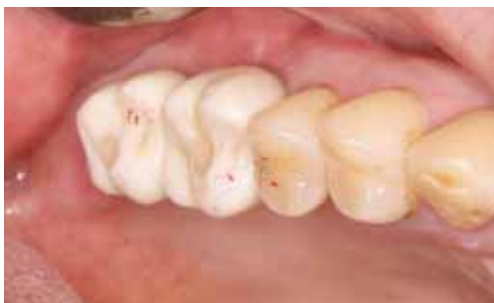
Fig.5 Occlusal view : Access holes were filled with resin.

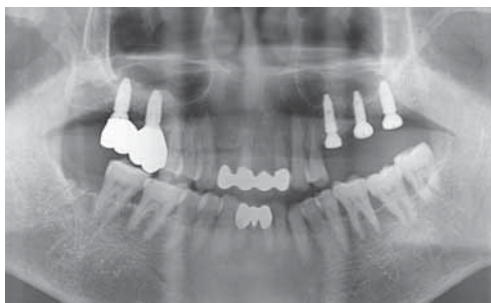
Fig.6 The final prosthesis on maxillary right posterior region was delivered.

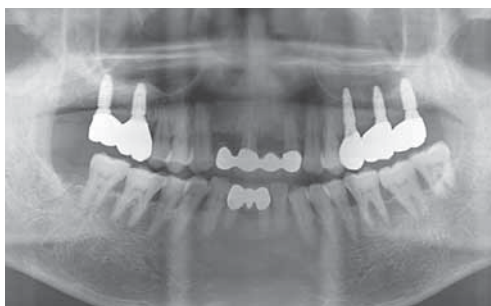
Fig.8 3-year follow-up panorama.

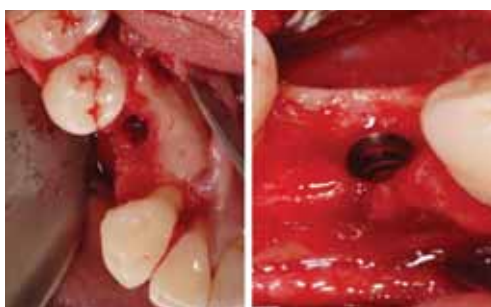
Fig.4 Buccal bone deficiency around IS-II implant. (4.0x10mm)

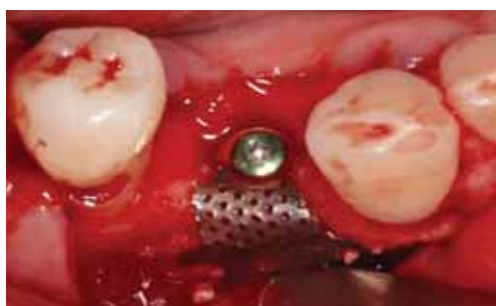
Fig.5 Bone graft material was covered and secured with CTI-mem.

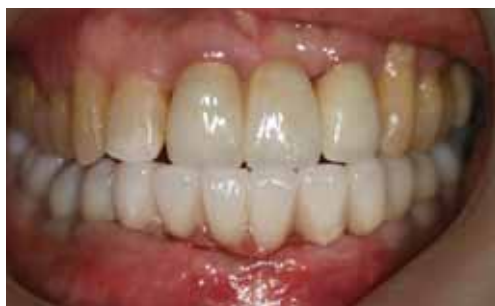
Fig.15 Final prosthesis. (zirconia fixed complete denture on implants)

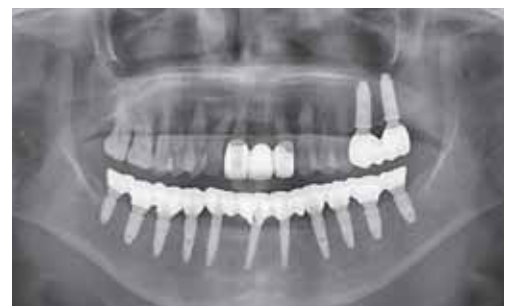
Fig.16 1 year follow-up.

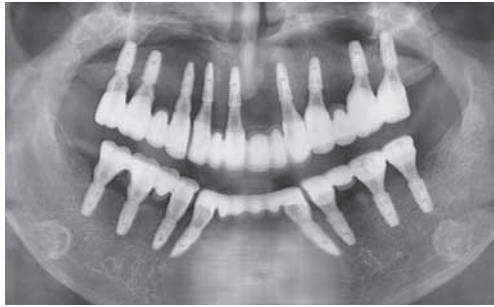
Fig.11 A panoramic radiograph after the final delivery of the prostheses.

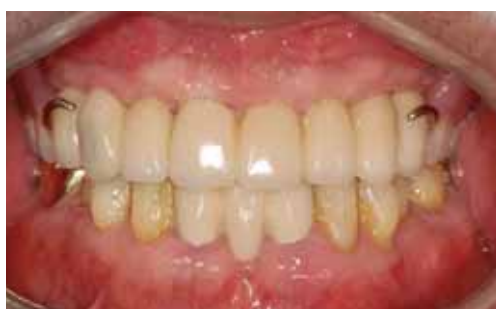
Fig.23 Prosthetic delivery.

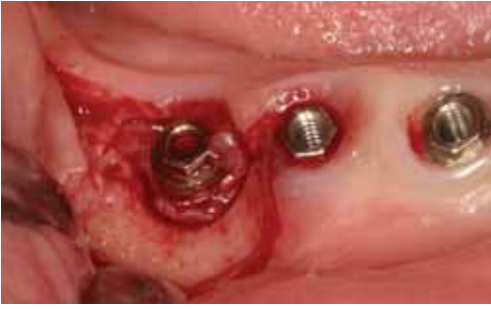
Fig.1 The implant was exposed with flap elevation and severe peri-implant bone loss was found.

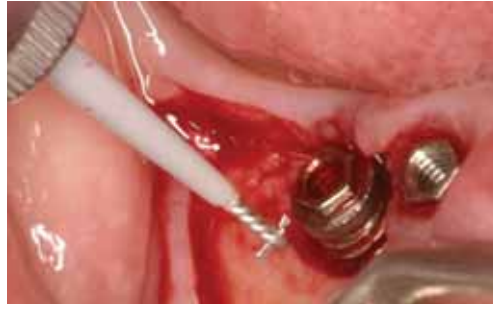
Fig.2 Each contaminated implant thread was cleaned with i Brush for 3 minutes, at 8000rpm.

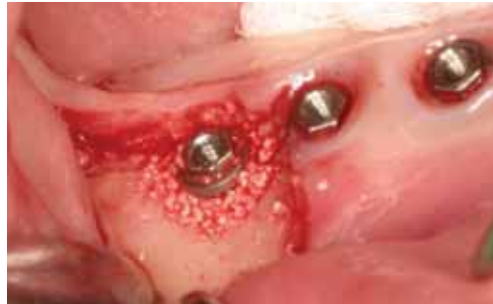
Fig.4 Bone material was applied to the defect.

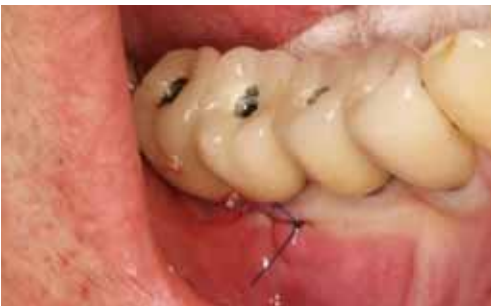
Fig.5 Original bridge was delivered on the implants right after the surgery.

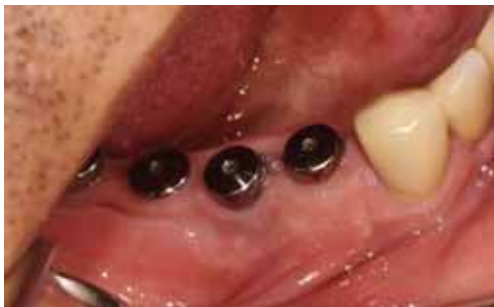
Fig.1 8mm of vertical bone loss was found on #45.

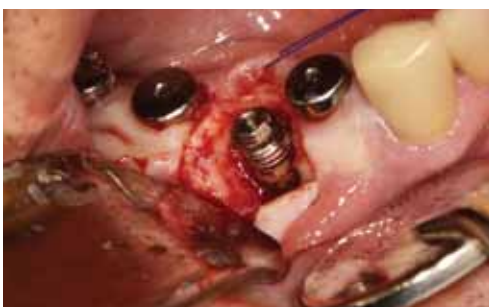
Fig.4 The implant was exposed with flap elevation and severe peri-implant bone loss was found.

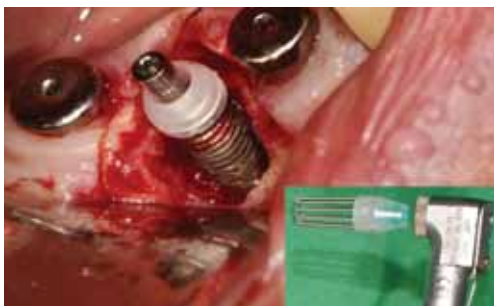
Fig.5 A R-Brush was used for mechanical cleansing of circumferential defect at 8000rpm

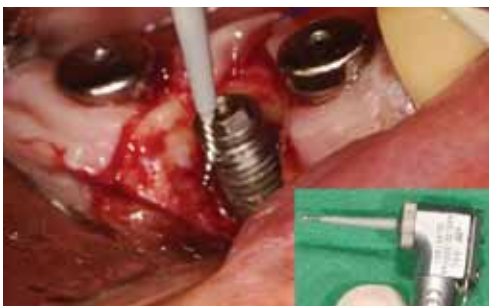
Fig.6 Noncircumferential defect was cleaned with an i Brush for 3 minutes each thread. It was used at 3000 to 5000rpm.

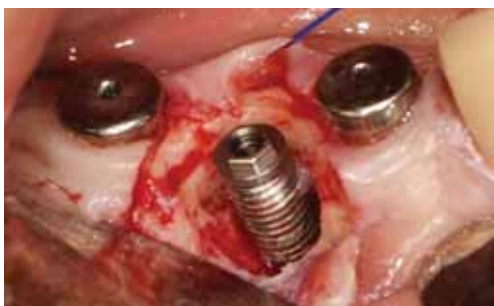
Fig.7 New rough surface has been created.

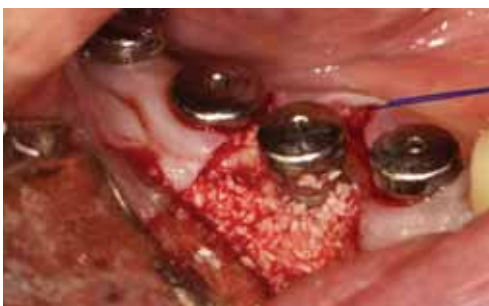
Fig.8 Bone material was applied to the defect.

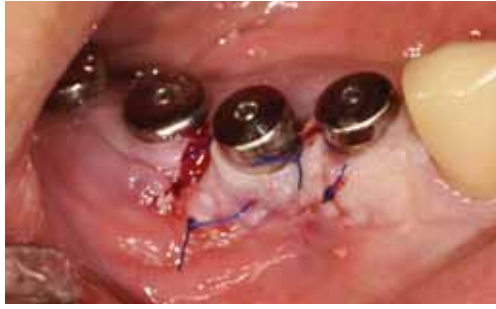
Fig.9 The wound area was sutured.

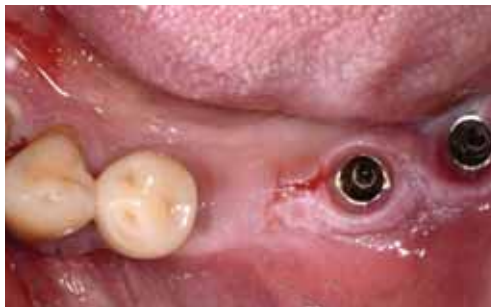
Fig.2 Existing implant prosthesis removal.

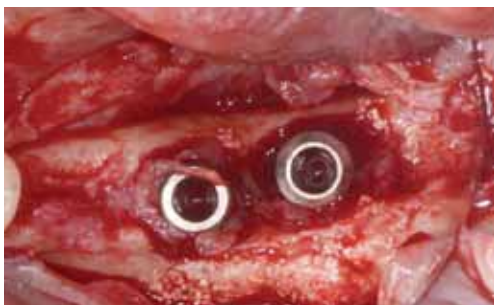
Fig.3 A broad bone loss occurred including inflammatory granulation tissue caused by peri-implantitis.

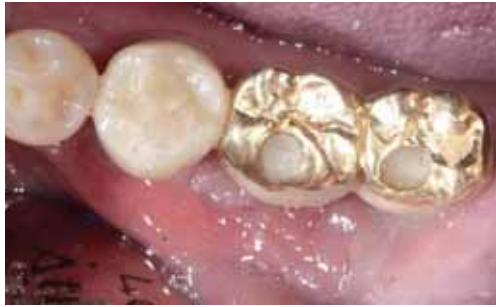
Fig.11 Existing prosthesis, additional implant placement on #35.

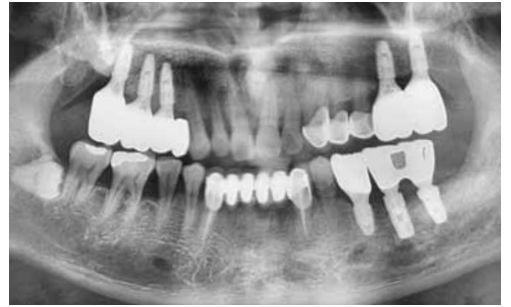
Fig.12 After 2 years.

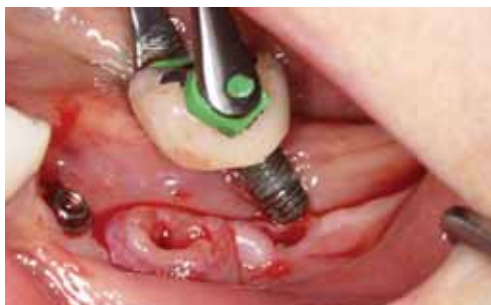
Fig.4 Failed implants #36 and #37 were easily removed with a crown remover.

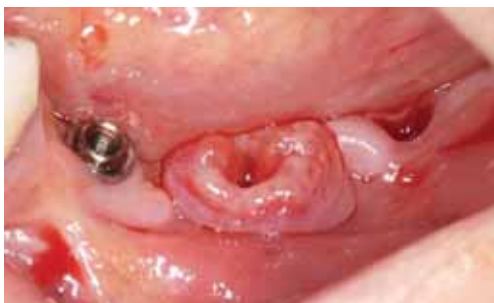
Fig.5 The buccal view following removal of #36 and #37.

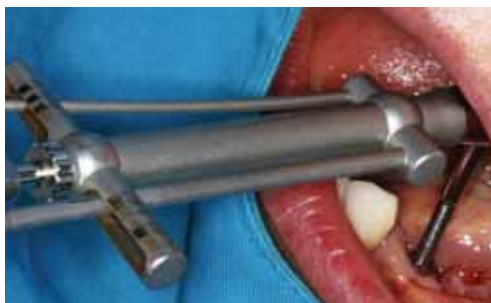
Fig.6 A fixture remover screw was screwed into the implant fixture #35 with 70Ncm of wrench torque. (less than 80Ncm is recommended)
