NEOBIOTECH

USER'S
CLINICAL
CASES

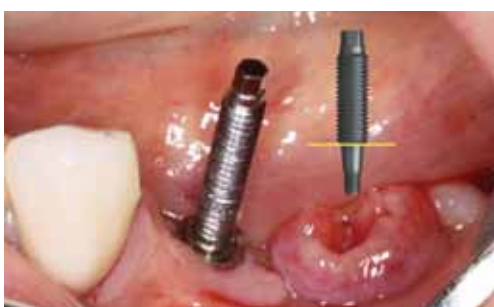
Fig.7 A fixture remover screw must be inserted to the yellow line marked on a 3D image to prevent them from getting fractured. Bottom threads are in the opposite direction to upper threads.

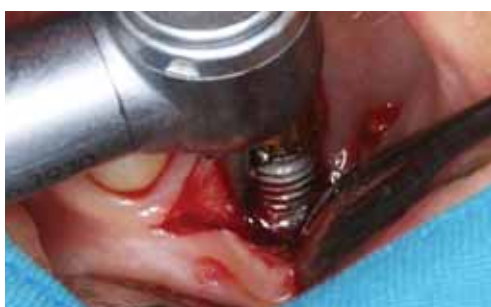
Fig.8 A fixture remover that fits to the coronal part of the implant was screwed on the removal screw in counterclockwise direction. 300Ncm counter-torque was applied with copious water, but failed to unthread the implant.

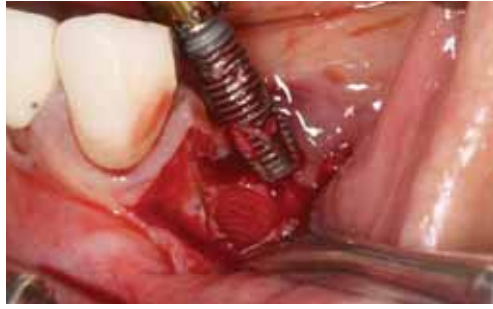
Fig.9 With 1mm of crestal bone prep, the implant started to come out at 200Ncm counter-torque.

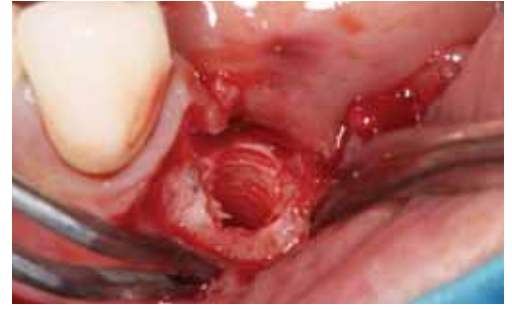
Fig.10 As the favorable bony conditions of threads are preserved, implant may be inserted again with good prognosis.

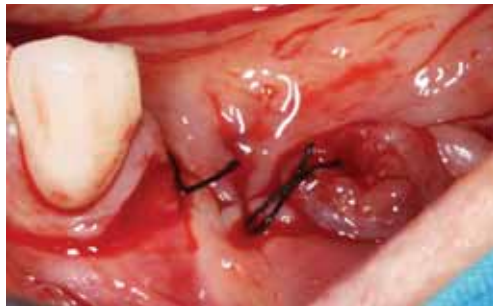
Fig.11 The surgical site was simply sutured.

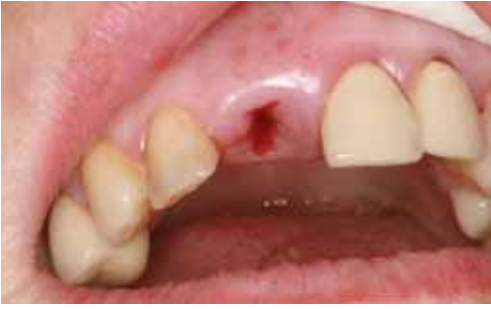
Fig.1 Condition of the patient 5 days after the crown was lost.

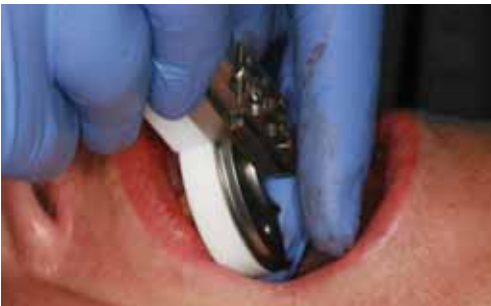
Fig.3 Under infiltration anaesthesia the fractured root was removed atraumatically with periostomes and a Bendix device manufactured by Zepff.

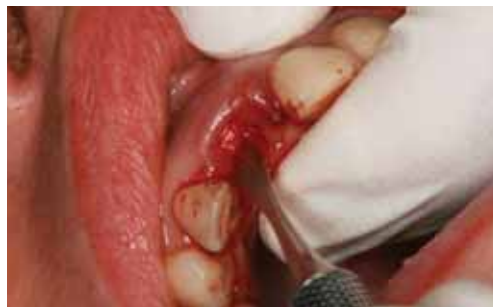
Fig.8 The fissure between the implant and the vestibular bone lamella was augmented.

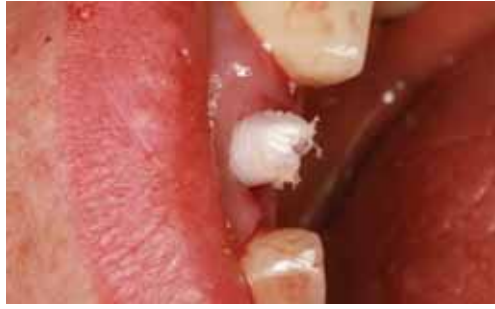
Fig.9 A prosthetic restoration was preformed supported by a temporary connector.

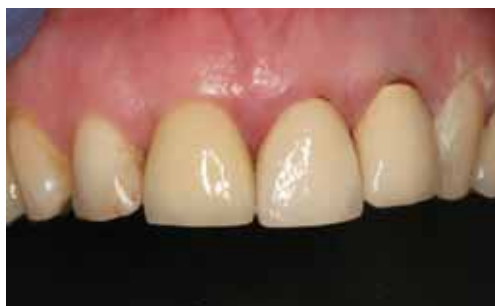
Fig.15 The final prosthetic restoration was formed.

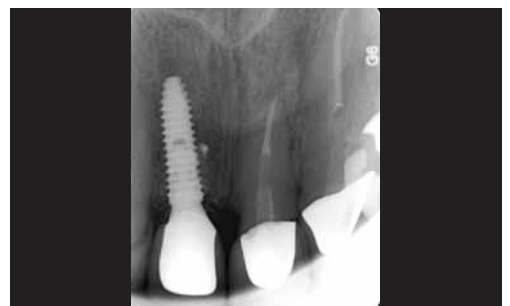
Fig.16 A periapical x-ray was performed to evaluate embedment of the restoration.

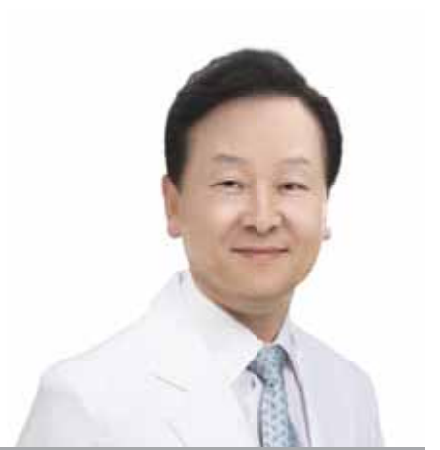
Dr. Young-Ku Heo
DDS, MSD, Ph.D

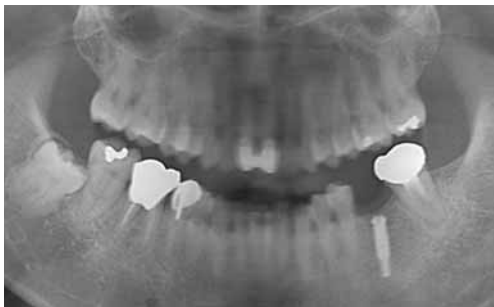
Fig.1 A 47 year old male patient was referred to the clinic with a fractured implant screw.

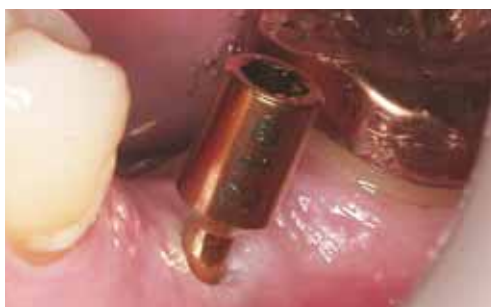
Fig.4 A Ø1.2mm perfect guide was tightened to 15Ncm in the screw hole. A perfect guide positions a drill the dead center of the screw and prevents it from damaging the threads of the implant.

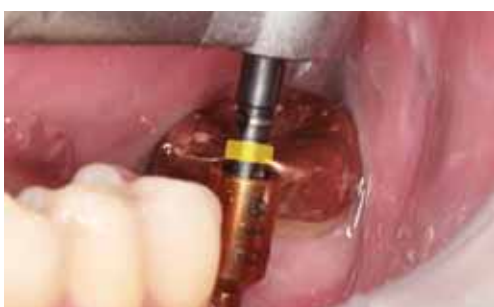
Fig.7 Using a perfect guide, a reverse drill was placed right on top of the fractured screw. Then approximately 1.0mm was gently drilled vertically down. The use of rubber stoppers is suggested for 1.0mm of depth control.

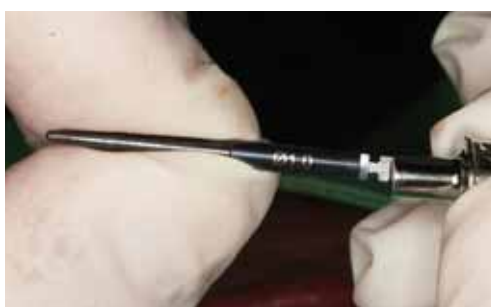
Fig.8 A Ø1.0mm screw remover matching to the reverse drill is being connected to a shank driver.

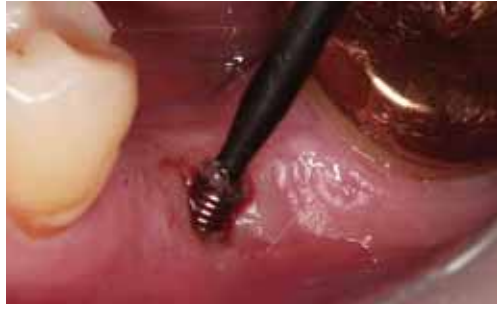
Fig.9 The fractured screw was being removed by rotating the screw in counterclockwise direction.

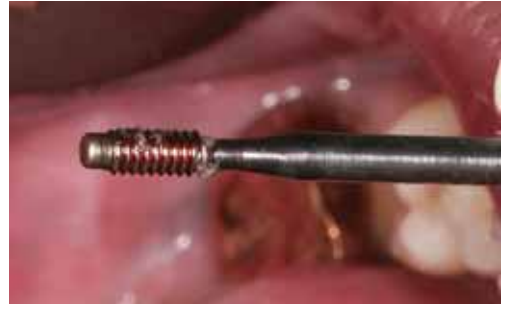
Fig.10 The fractured screw came out of the screw hole.

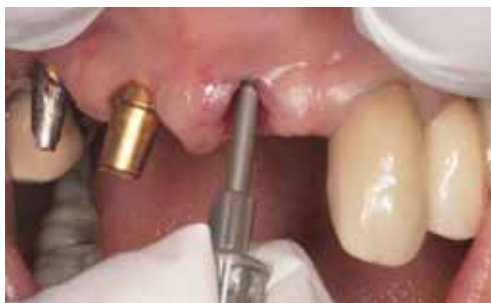
Fig.6 The fractured screw was being removed by rotating the screw in counterclockwise direction.

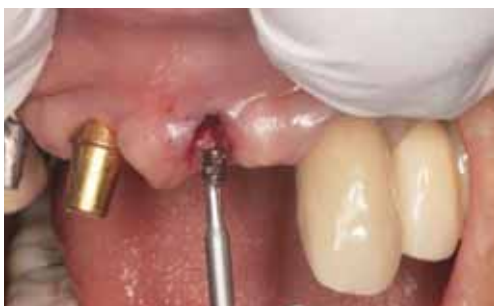
Fig.7 The fractured screw came out of the screw hole.

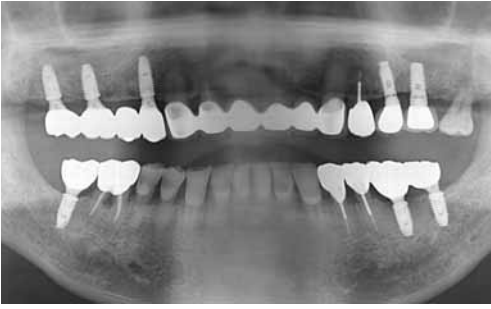
Fig.1 #24 was planned to be replaced with an implant, because it was considered hopeless after a half year of the endodontic treatment.

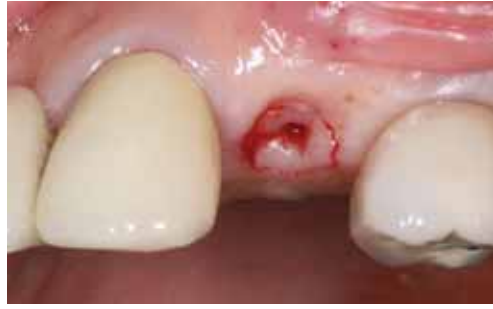
Fig.2 After 1 months of #24 extraction, flapless implant surgery was performed by tissue punching.

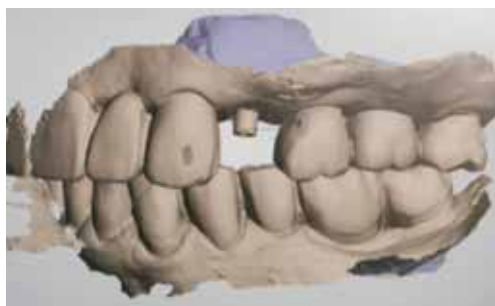
Fig.15 Side view of the intraoral scan: Intraoral scanner (Trios) enables positioning of an implant and milling of prosthetics on the computer.

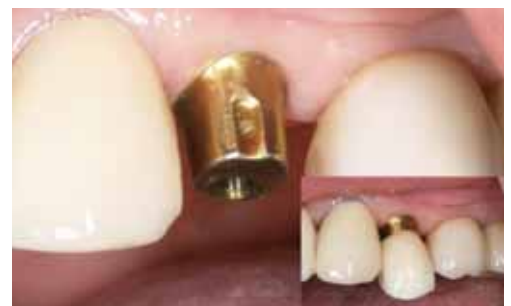
Fig.16 The customized abutment was fabricated without using a model.

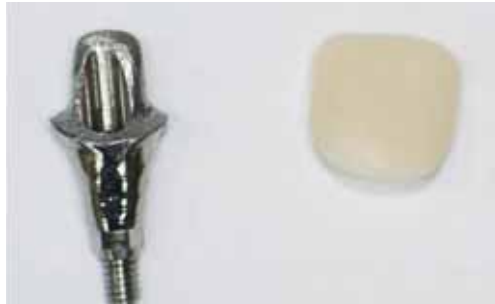
| Fig.11 Custom abutment & temporary crown.

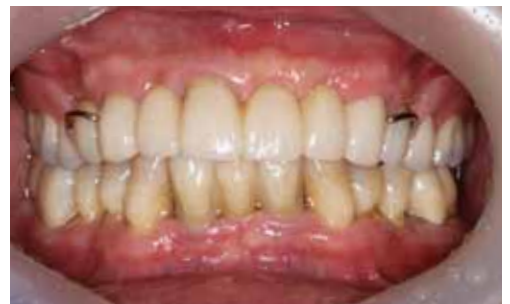
Fig.32 Final prosthesis after 5 months.
(zirconia fixed denture)

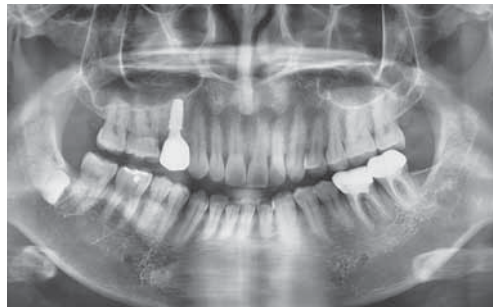
Fig.8 A panoramic radiograph after the final delivery of the prosthesis.

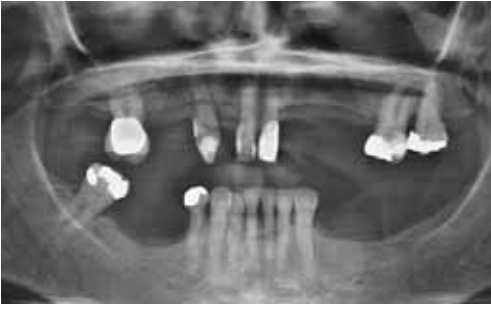
Fig.1 This case presents full mouth teeth replacement with All-on-4 concept treatment.

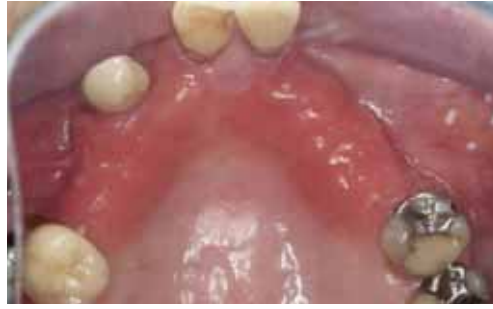
Fig.2 Preoperative Photographs.

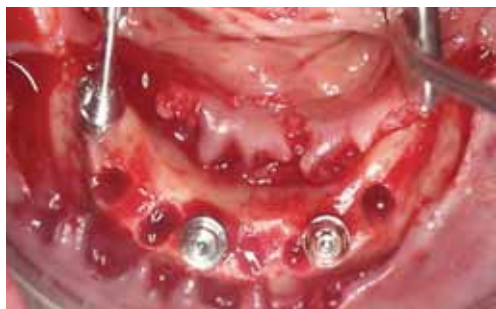
Fig.17 Multiunit Angled Abutment : Different point of engagement = Different prosthesiss screw hole axis.

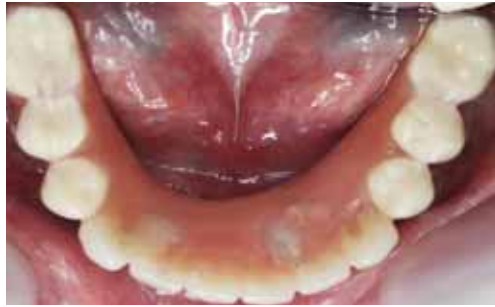
Fig.59 6th appointment : Recheck (after insertion 1 day) : After treatment.

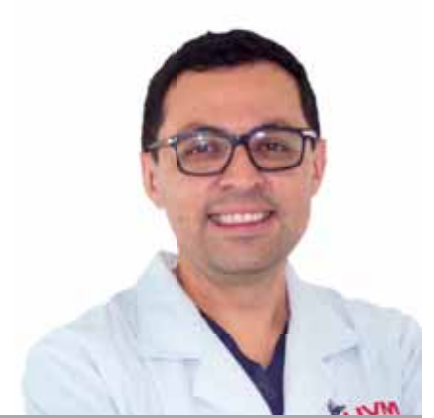
Dr. MANUEL FEREGRINO MÉNDEZ
DDS

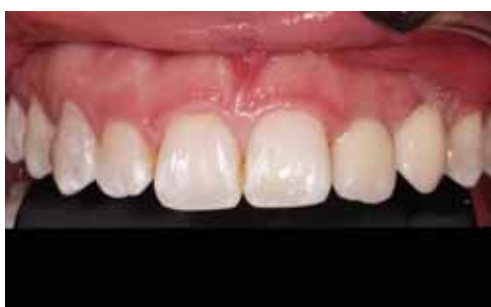
Fig.40 Final prosthesis.

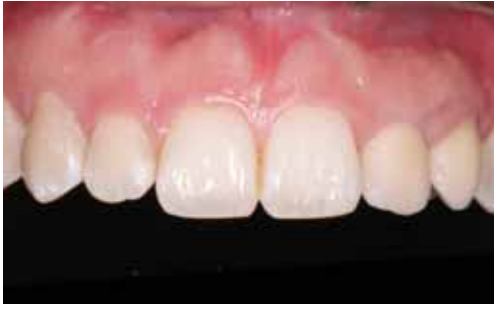
| Fig.41 4 years follow up.
